NBSIR 77-1399

Performance of A Water-Thinned Polyurethane Seamless Flooring System

December 1977

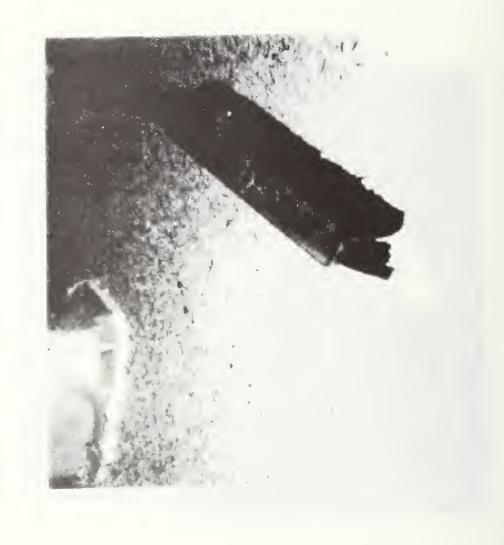
The skill of the applicator was reflected in the number of vertically protruding chips. Horizontal arrangement of the chips is due, in part, to the skill of the applicator in applying the glaze coat. Protruding chips frequently inhibit pedestrian foot movement and contribute to uncomfortable walking conditions.

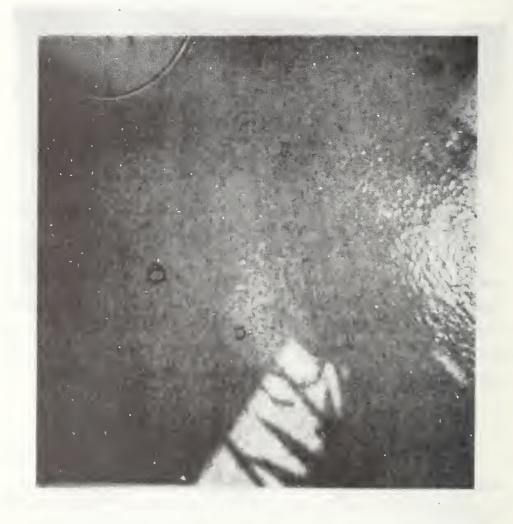
- 1. Discoloration was evident.
- 2. Dusting of the finish was observed.
- 3. Numerous stains were noted (see Figures 6-9).
- 4. Abrasion was evident in high-traffic areas.
- 5. Several indentations were noted.
- 6. Overall appearance was judged fair to poor.
- 7. Dirt was embedded in the surface of the system.

Figure 6 Cigarette Burn and Chemical Staining of the Water-Thinned Polyurethane System

Figure 7 Multiple Staining of the Water-Thinned Polyurethane System

Solvent and Rust Staining of the Water-Thinned Polyurethane System Figure 8

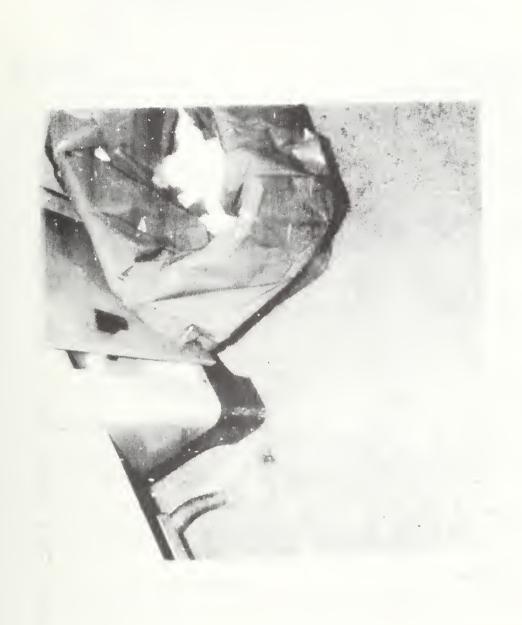
Figure 9 Furniture Staining and Indentation of the Water-Thinned Polyurethane System
